Wind Turbine Testing

WT14 Failure 1 @ PFS-South on January 11, 2013

WT14 Failure 2 @ PFS-South on 2013-03-04

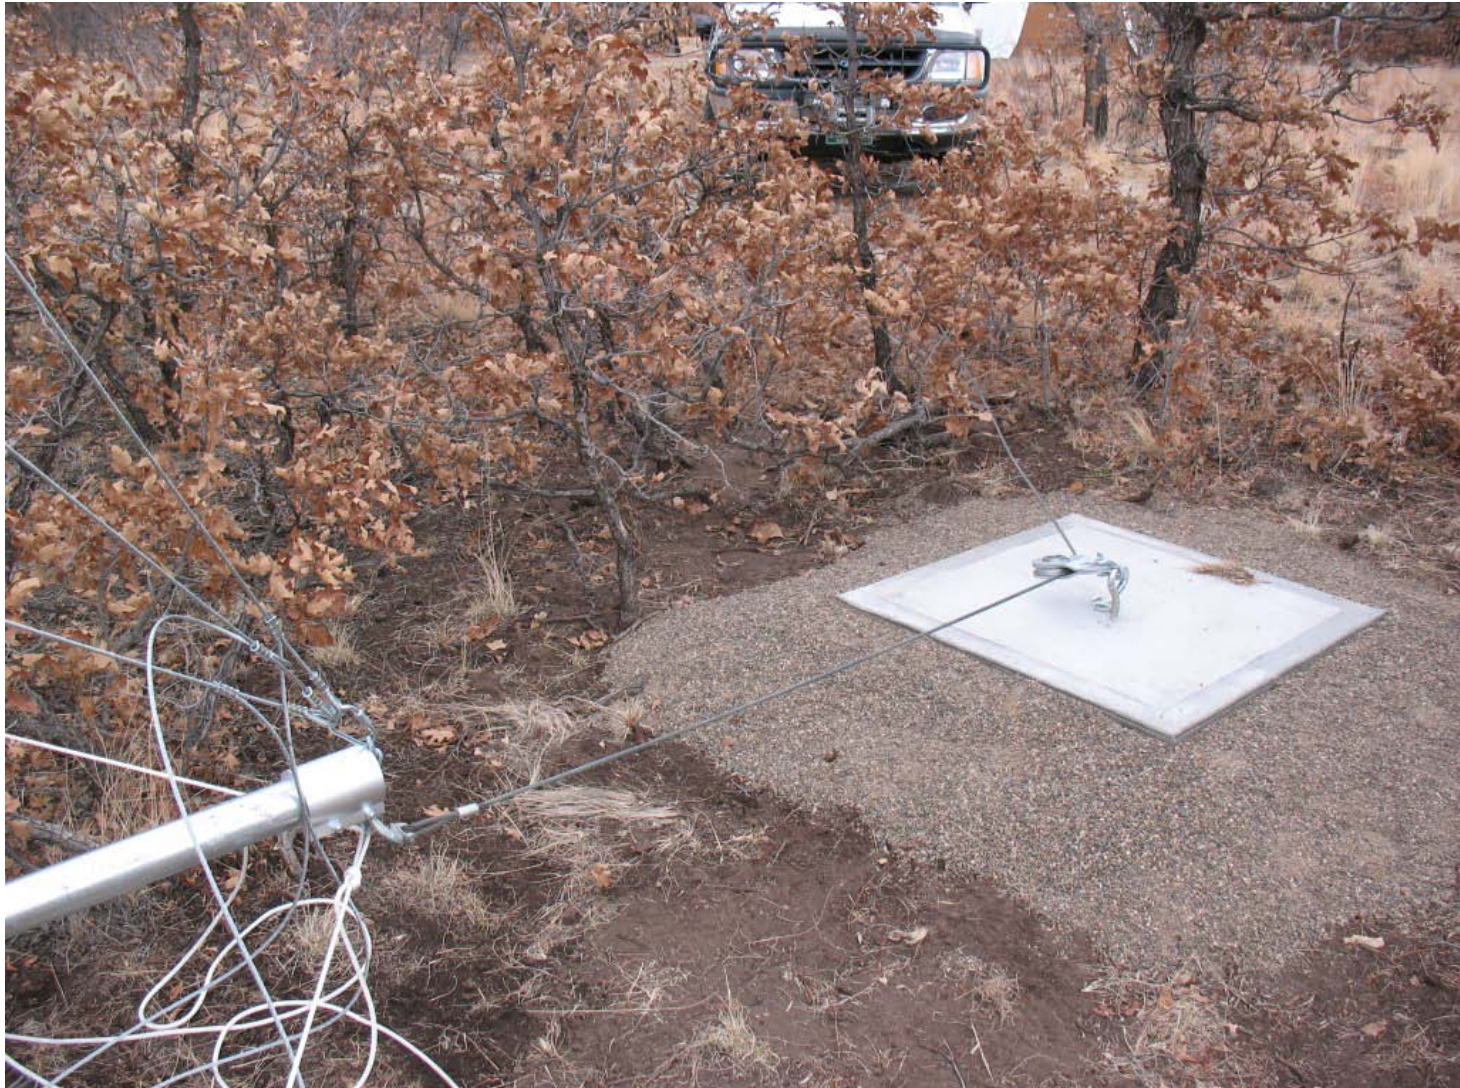
Raise/Lower System

- 50' guyed, tilt-up type tower from SWWP provides economical system, easy to access turbine (about 15 - 20 minutes to lower)
- Robust foundation and grounding system
- 2.5" schedule 40 pipe can handle up to 1kW machines
- WLAN/broadband satellite communications
- APRS World supplied monitoring system
- Back-up solar (PV) system to keep batteries charged

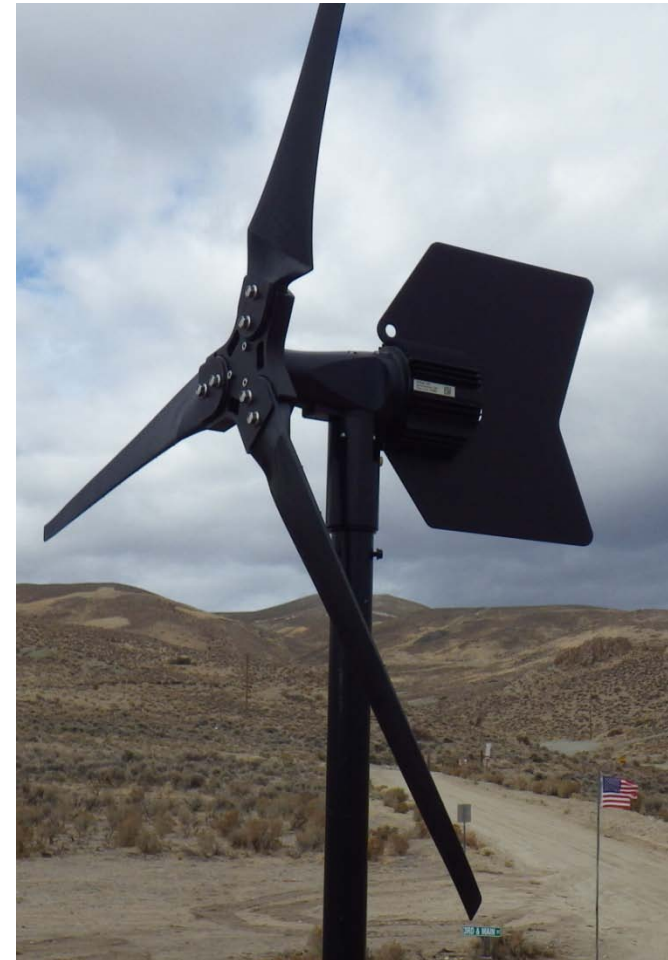
WT14 Wind Turbine

- 3 blades, horizontal axis, upwind
- Rotor
 - 1.4 m (4.7 ft) rotor diameter
 - Glass filled nylon blades
- Generator
 - Permanent magnet
 - 3Ø
 - Variable voltage and frequency
 - 1kW nominal capacity
- 11 kg (24 lbs) weight

- Battery charging 24 or 48 volt battery
 - 4.5 m/s (10 MPH): cut in speed
 - 5.4 m/s (12 MPH): 50 watts!
 - 13.5 m/s (30 MPH): 300 watts
 - 55 m/s (123 MPH): survival speed
- *“Optimized for power production in moderate wind regimes. Survives occasional intense high wind.”*

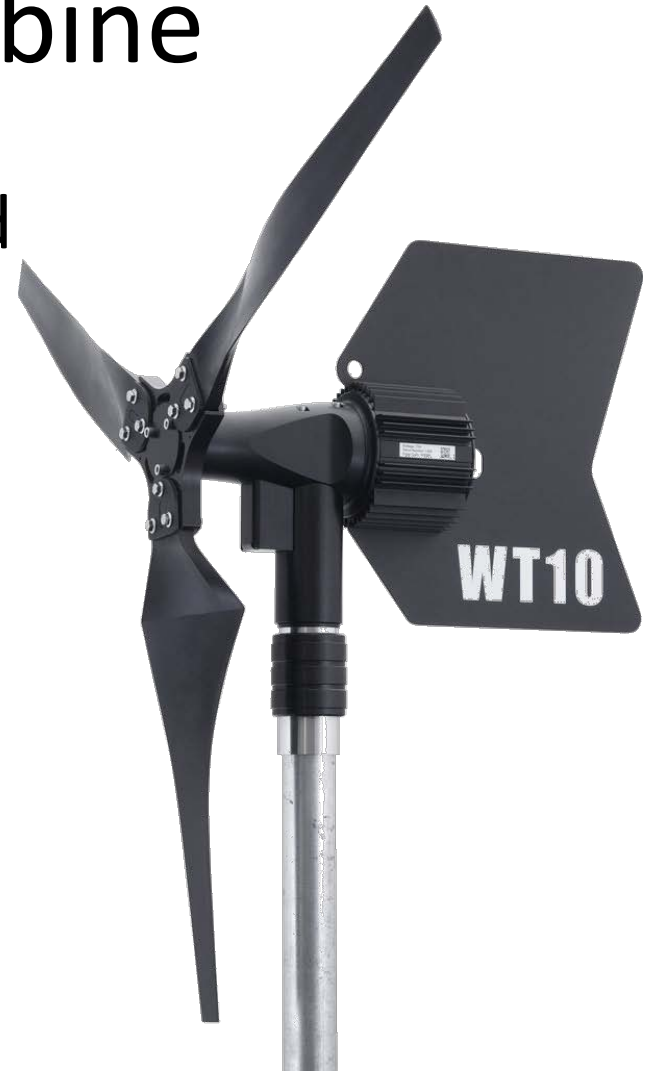
WT10 Wind Turbine

- 3 blades, horizontal axis, upwind
- Rotor
 - 1.0 m (3.3 ft) rotor diameter
 - Glass filled nylon blades
- Generator
 - Permanent magnet
 - 3Ø
 - Variable voltage and frequency
 - 1kW nominal capacity
- 10 kg (23 lbs) weight

- Battery charging 24 or 48 volt battery
 - 4.5 m/s (10 MPH): cut in speed
 - 13.5 m/s (30 MPH): ~300 watts
 - 31.5 m/s (70 MPH): ~750 watts
 - >70 m/s (>157 MPH): survival speed
- *“Optimized for high wind energy sites.”*

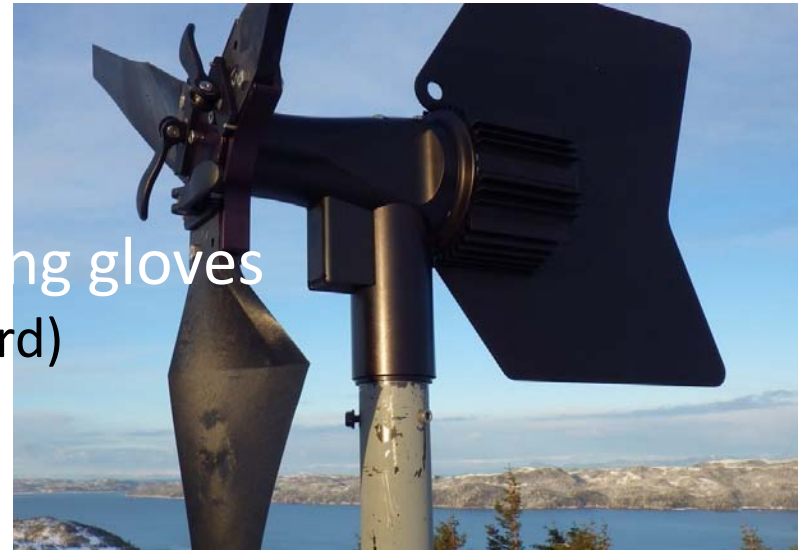
WTAPRS Polar Relevant Features

- Light weight and compact
- Installation
 - Tool less assembly while wearing gloves
 - Connectorized electrical (standard)
 - Quick attach tail (standard)
 - Quick attach blades (option)
 - Quick attach to mast (option)
 - Very quick installation
 - Materials selected for resilience at low temperatures
 - Easy to rig
 - Carabineer hole for lifting
 - Can be attached to harness and carried up tower

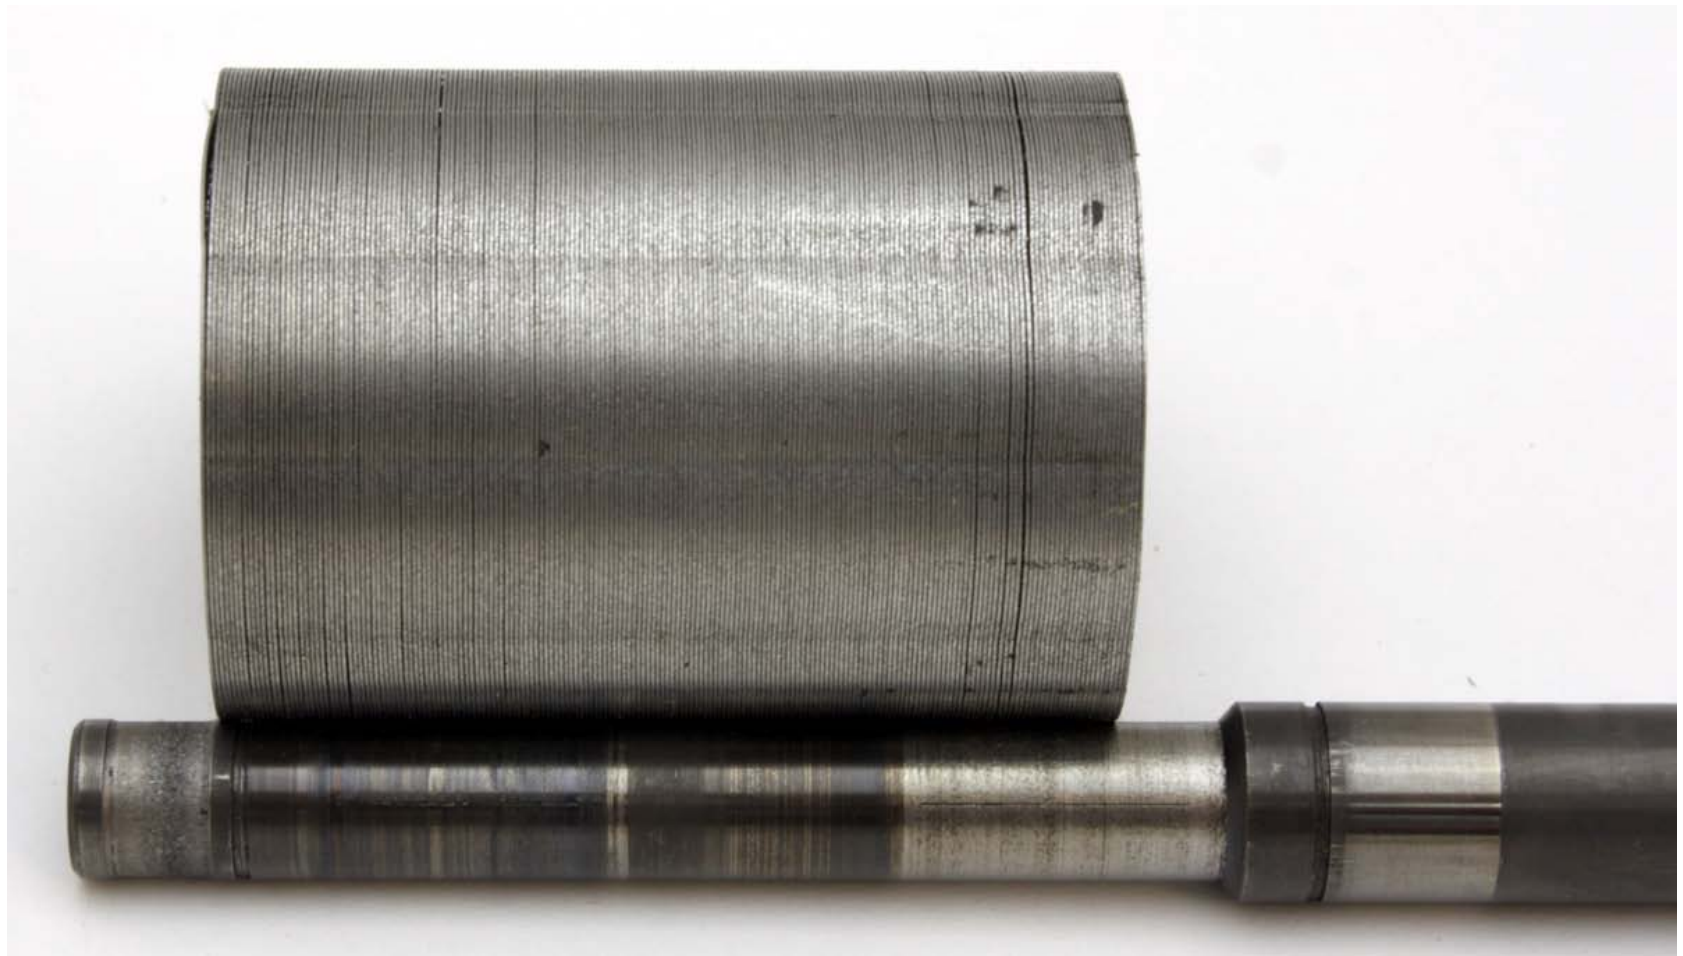
Failed Rotor / Shaft

- Problems
 - Internal permanent magnet generator failure
 - Rotor became detached from main shaft
 - Hub / main bearing interference
 - Rotating part wore and came in contact with non-moving nose of turbine
 - Yaw
 - Turbine would yaw 360° in high winds

Permanent Magnet Generator Failure

- Known weakness in design of rotor to shaft interface
 - Manufacturer is beginning to manufacture improved design with multiple rotor to shaft retention features
- Manufacturer attributes to wind event exceeding ratings of turbine and exasperating known design weakness

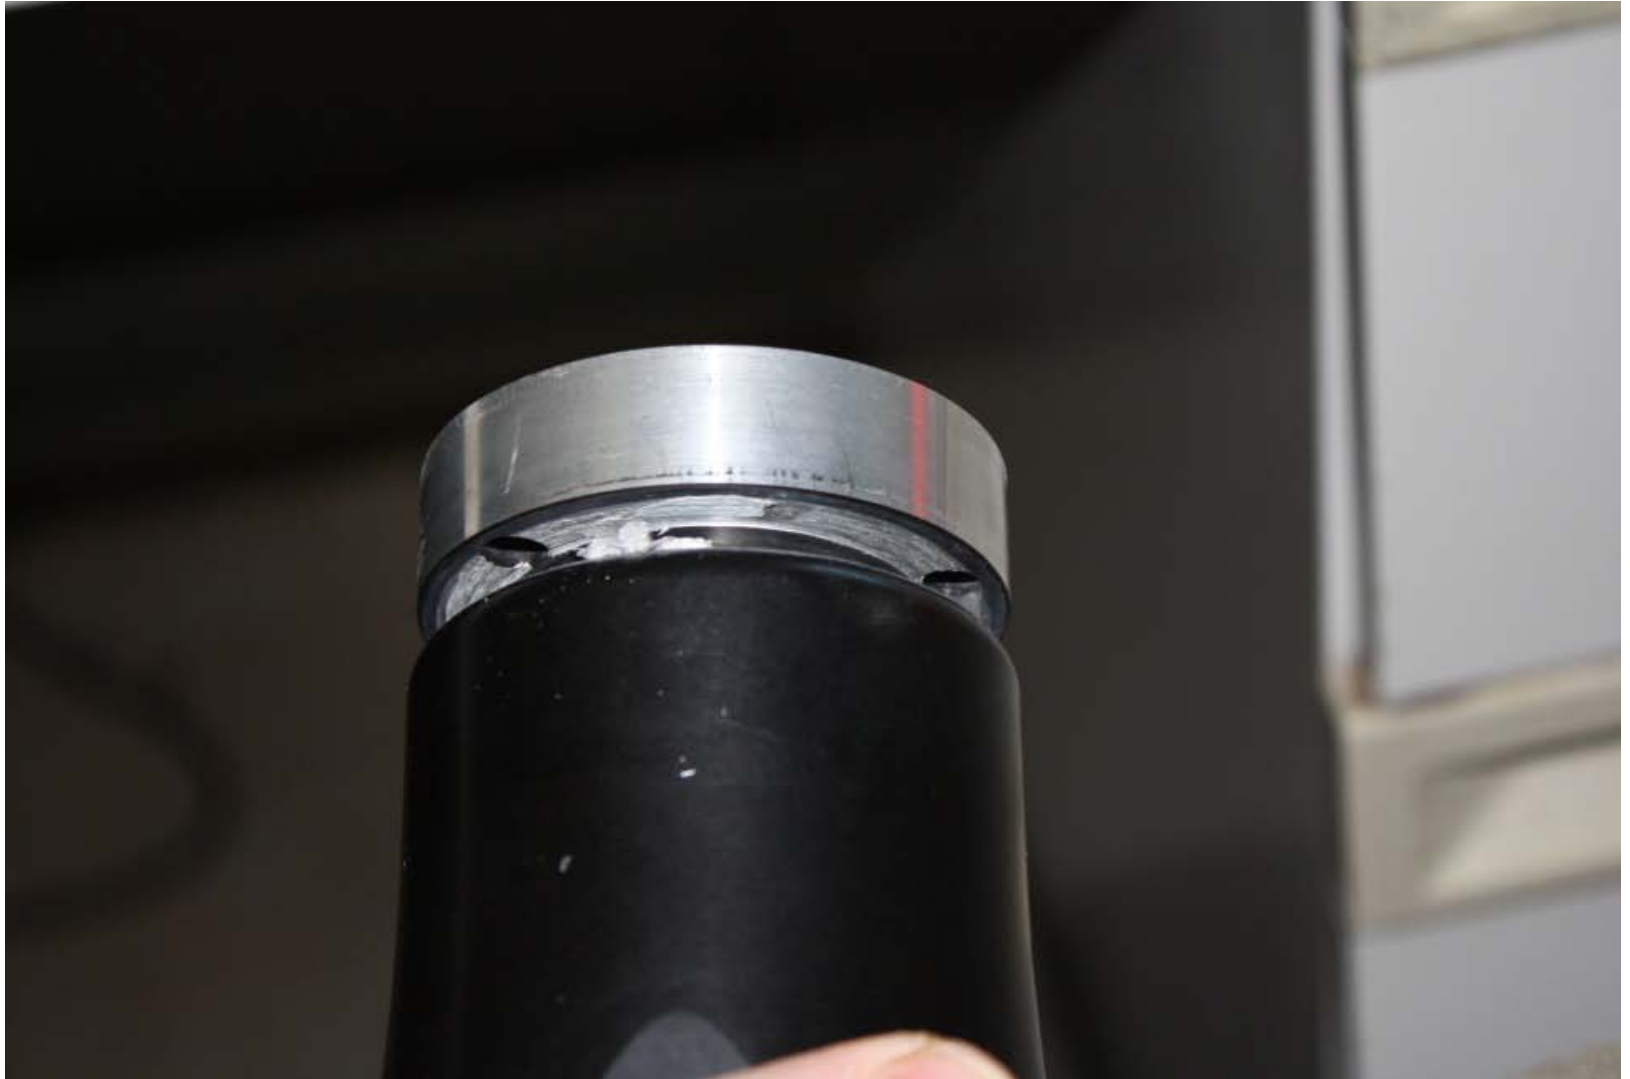
Hub / Main Bearing Photo

Hub / Main Bearing Interference

- Defect in design
 - Previous generations had much larger gap between rotating hub and fixed body
 - Smaller gap adopted to minimize area for ice accumulation
 - Wear in component allowed surfaces to rub
- Manufacturer attributes to design defect and premature failure caused by **excessive turbulence** in high winds.

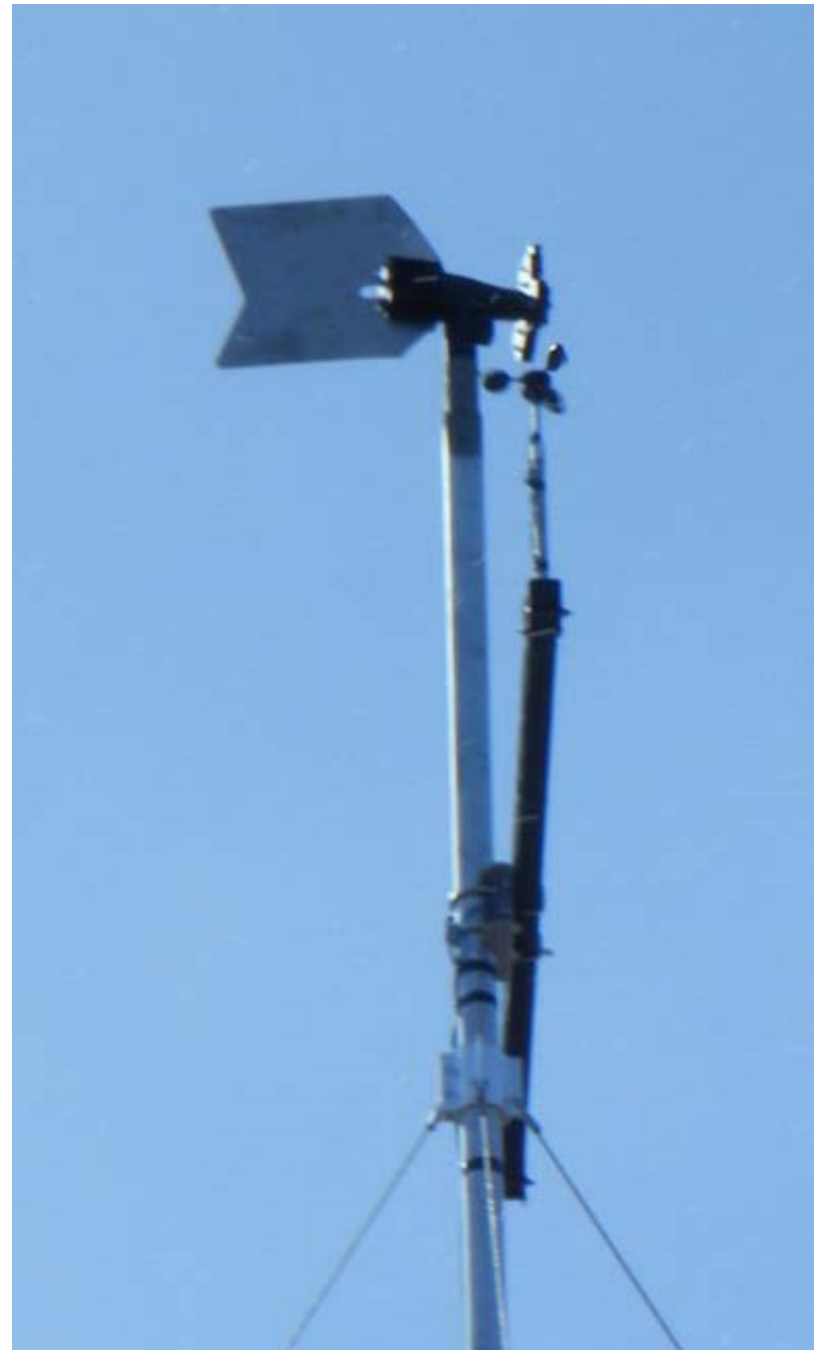
- Turbine failure in high wind 40 m/s (90 MPH) event
 - Loss of blades
 - All three blades broke at root
 - Root of blades remained bolted to hub
 - Bent tail
 - ~15 degree bend in PROTOTYPE larger tail

- Hypothesis: Blade injection molding process / mold design causes weak spot at location where blades failed
- High wind events / rotor over-speed stress the blades and caused failure
- Manufacturer is modifying injection molding tooling to eliminate weak spot around hold in blade
- Manufacturer attributes failure to turbine exceeding survival speed and design defect in blade tool.

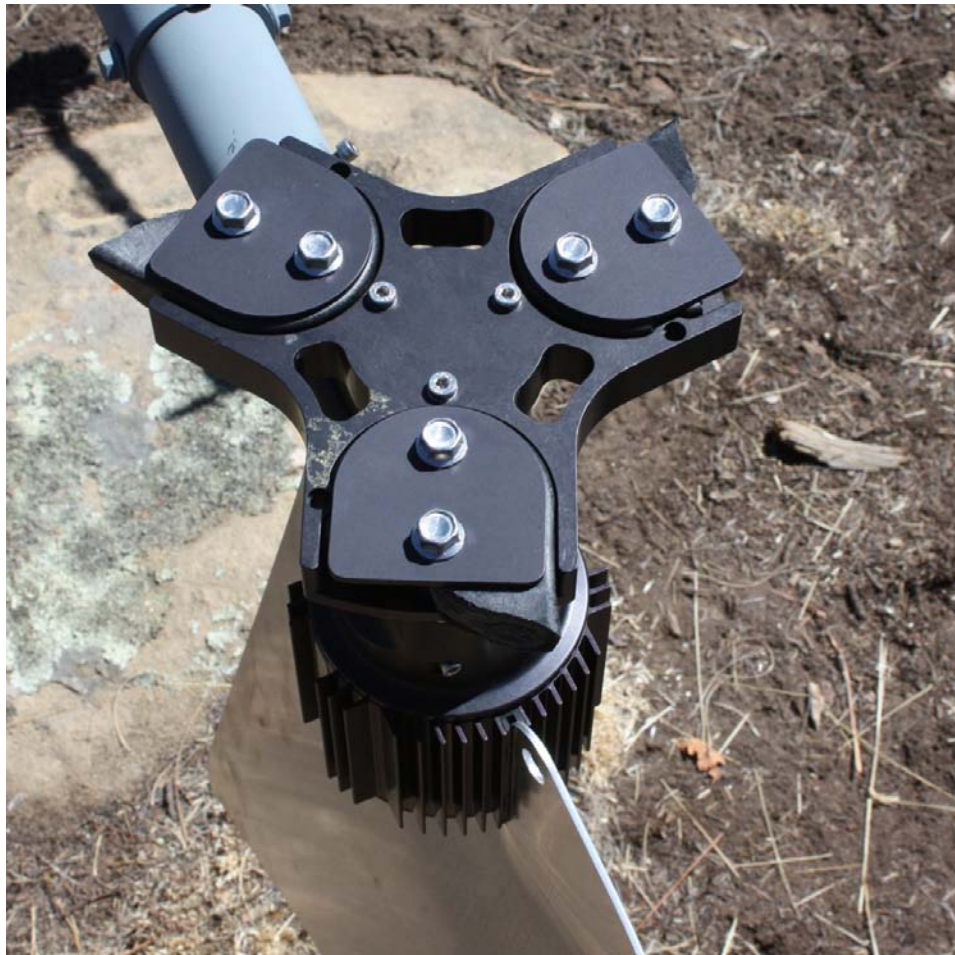
WT14 Failed Blade and Tail

Loss of Blades

Bent Tail

- Damage to turbine housing where tail installs indicates large motion in tail.
- Likely caused by unbalanced momentary operation of the turbine with 1 or 2 blades.
- Note: This was a prototype tail that is larger than production WT14 tail. Increased size has larger moment and may exceed yield strength of material.
